NBSIR 81-2191 (DoE)

The Use of the Slow Strain Rate Technique for the Evaluation of Structural Materials for Application in High-Temperature Gaseous Environments

Final Report

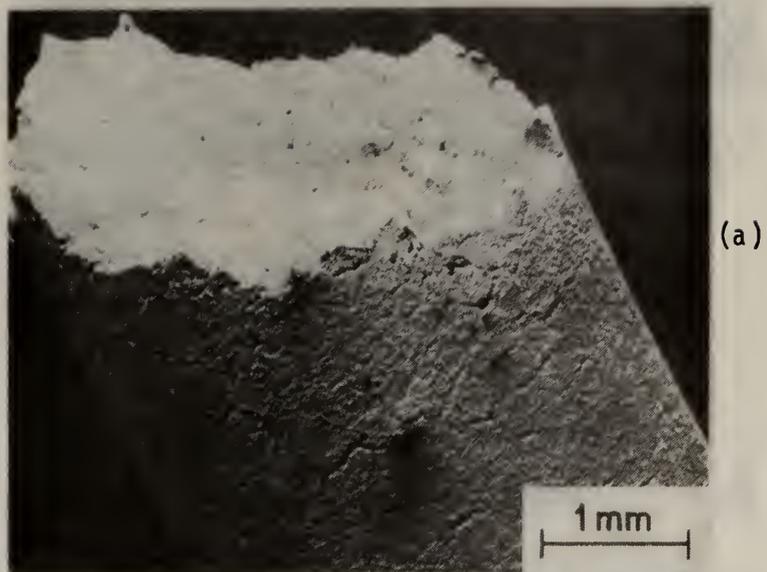
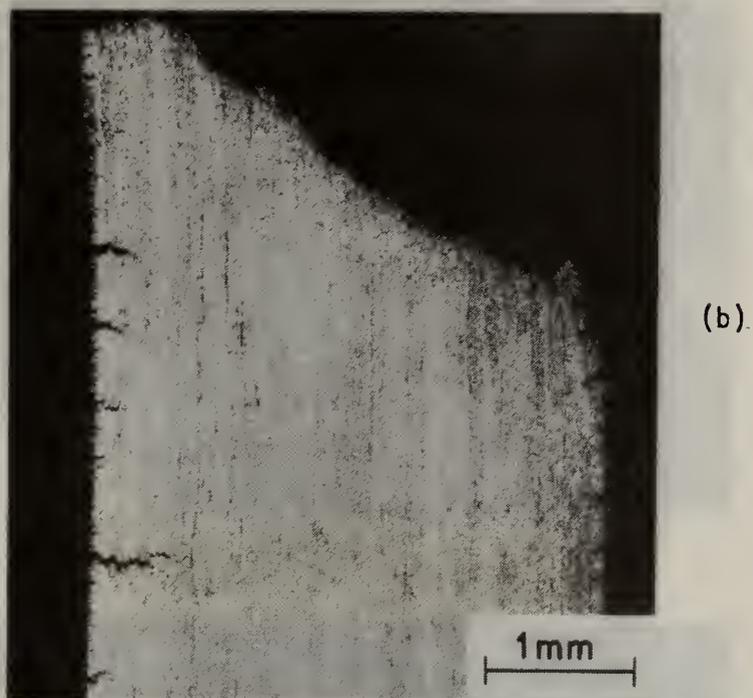
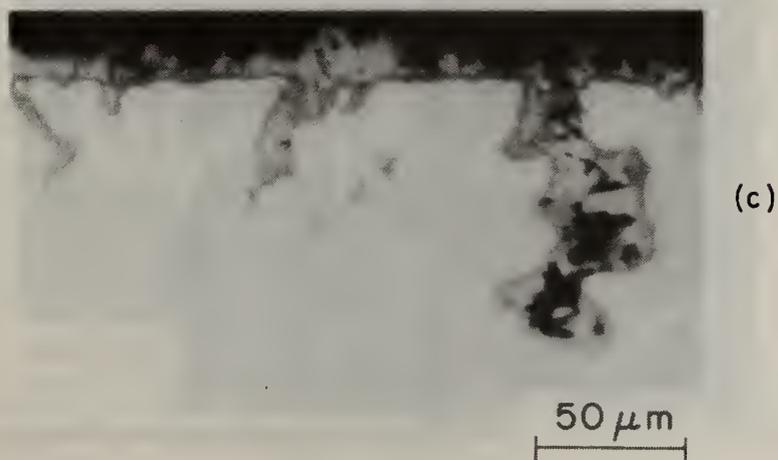
Fig. A-1. Type 310 specimen tested at 540 °C (1000 °F) at a strain rate of 10^{-6} /s in H₂S plus steam. (a) SEM of specimen at region of fracture. (b) Photomicrograph of etched cross-section near fracture. (c) Photomicrograph of cracks in the unetched profile.

The microprobe analysis has revealed that the duplex corrosion products on the surface of the specimen and in the cracks are mixed oxides and sulfides with the lighter colored corrosion product next to the bulk metal, rich in oxygen.

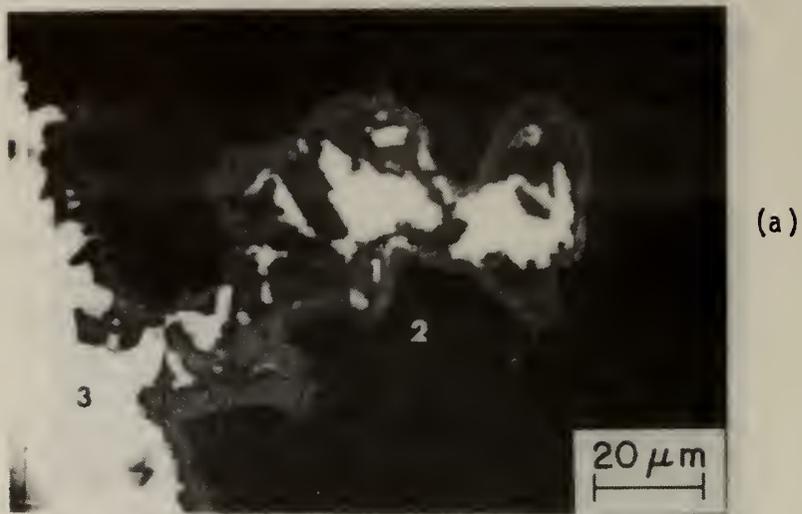
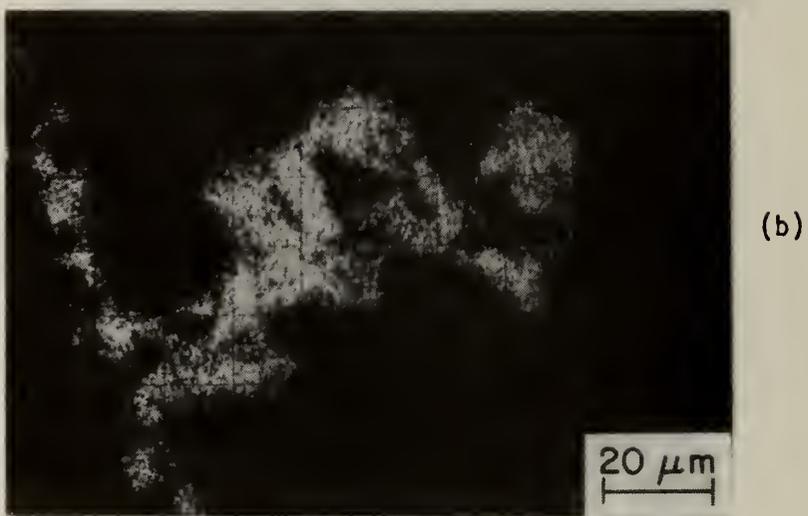
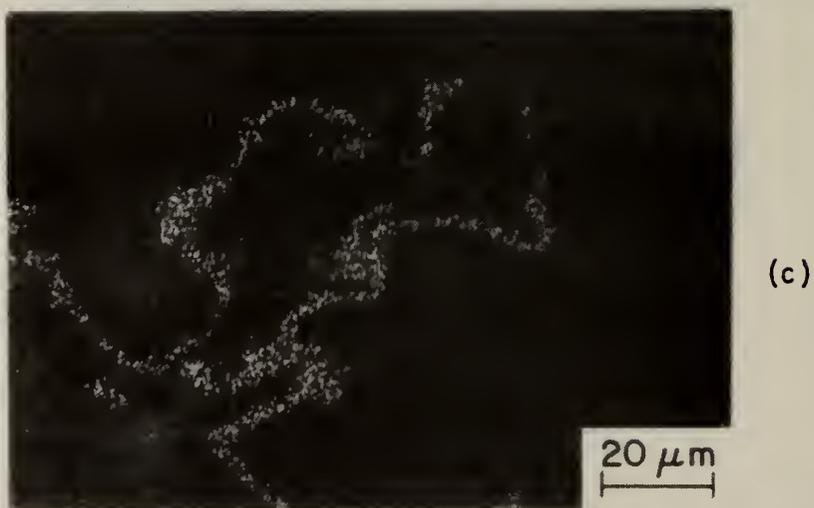
Fig. A-2. (a) Area of target current image for microprobe analysis.
(b) X-ray scan of crack showing sulfur distribution.
(c) X-ray scan of crack showing oxygen distribution.

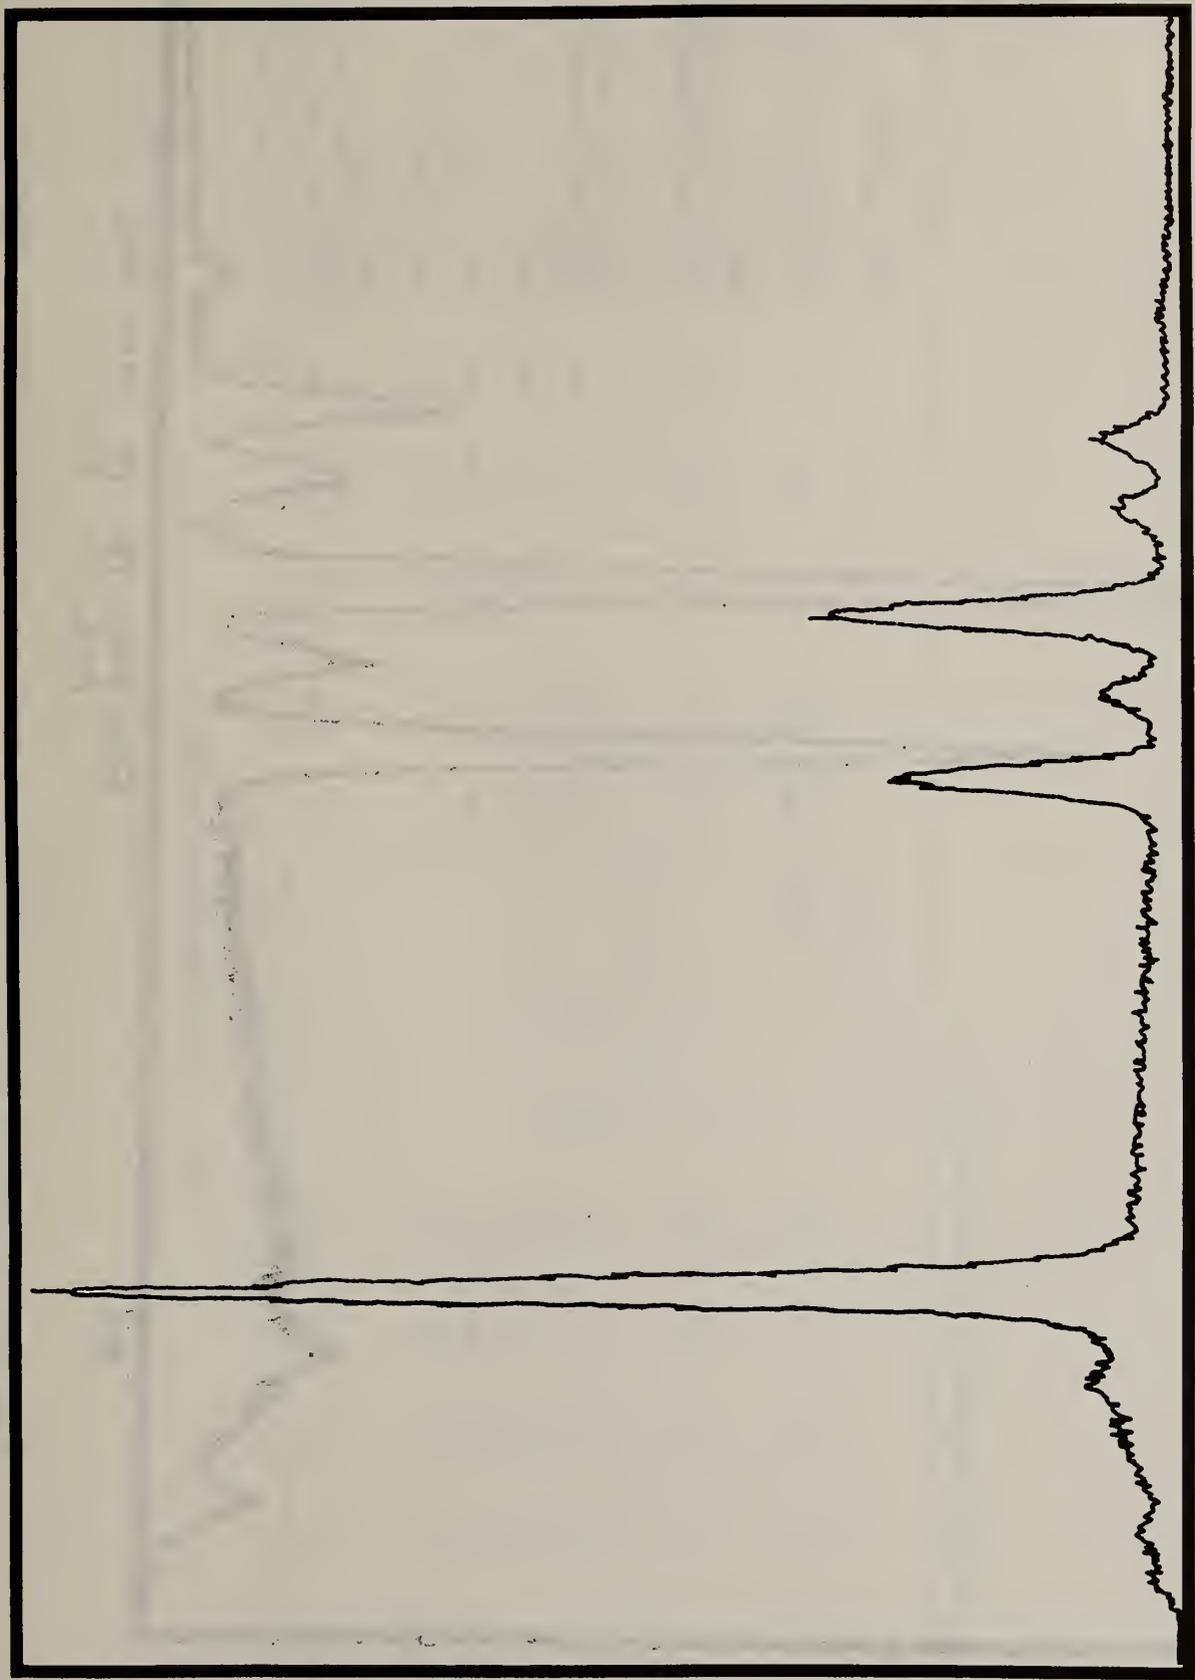
Fig. A-3. Microprobe analysis spectrum of the dark area within the crack. Area #1 from Fig. A-2a.

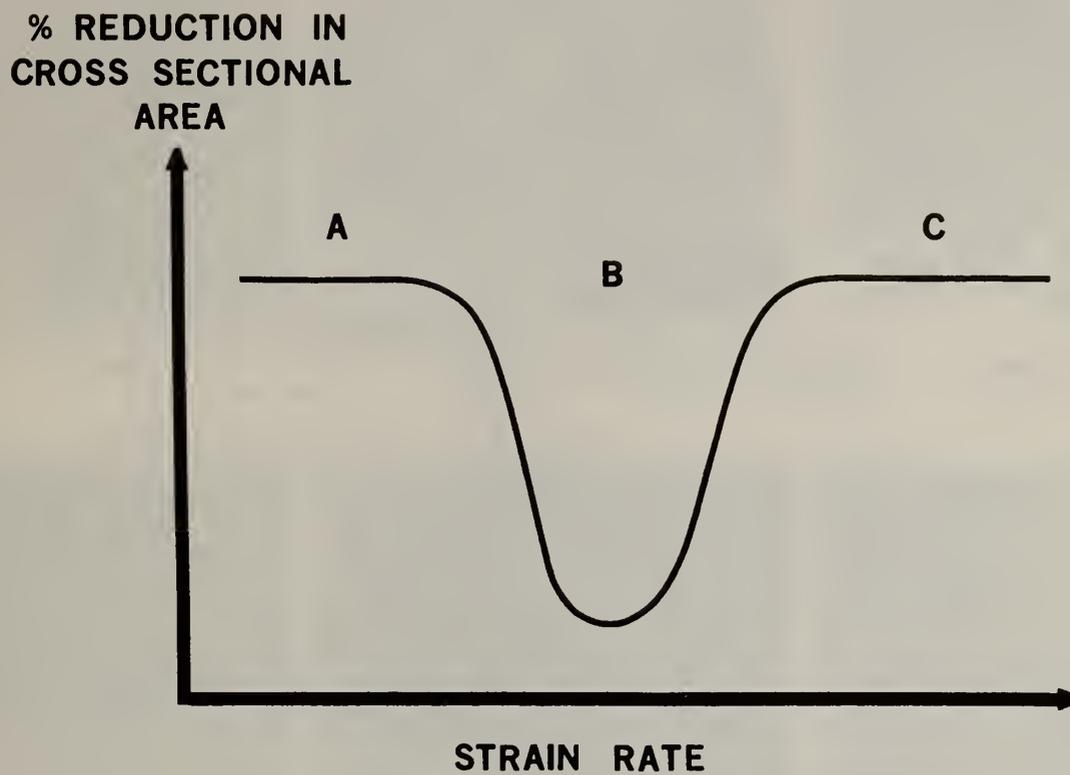
Fig. 1. Schematic representation of typical results obtained from the application of the SSRT to the study of SCC in aqueous media. The interpretation of Regions A, B and C is discussed in the text.

Previous work utilizing this technique had been confined largely to the study of stress-corrosion cracking (SCC) and hydrogen embrittlement in aqueous media.* The test involves the application of a slow strain rate to smooth, i.e., un-notched, tensile specimens which are simultaneously exposed to the environment being investigated, and yields data of the type shown in Fig. 1. Region A, where strain rates are too slow to lead to SCC, the rate of repassivation is thought to be rapid enough to prevent any damaging interaction between the environment and the bare metal exposed during straining. At the opposite extreme, Region C, the strain rate is so rapid that failure occurs by the normal ductile mode, the time being insufficient for environmental interaction to have a significant effect. It is only in the intermediate range of strain rates, Region B, where the rate of production of bare metal is sufficiently high so that the rate of repassivation does not effectively stifle environmental reaction and the strain rate is sufficiently slow so that ductile fracture does not predominate. Under these conditions, SCC takes place. If SCC is not possible for the system studied, the reduction in ductility shown in Region B does not occur; the presence or absence of this reduction of mechanical properties is the essence of the SSRT.

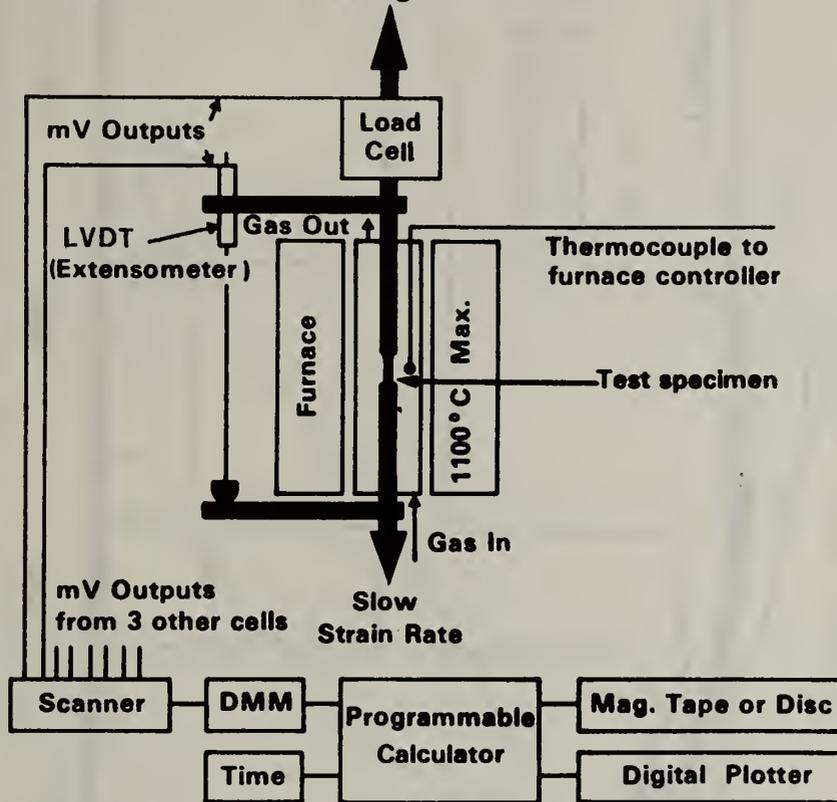
Fig. 3. A schematic representation of the slow strain rate testing facilities.

The test cells were Type 304 stainless steel tubes (38 cm(15 in) long by 5 cm(2.0 in) diameter sealed at both ends with Type 304 plates using Viton-A gaskets. The cells were mounted in furnaces capable of producing test temperatures up to 1100 C(200°F). Ports for entrant and exit gases, thermocouples, and specimens were available on the end plates, Fig. 3. Sliding seals of Teflon or high vacuum O-ring couplings provided freedom of movement for specimen extension while testing. These seals are limited in use to below 300 C(570°F) and therefore were located outside of the furnace and cooled with fresh air.

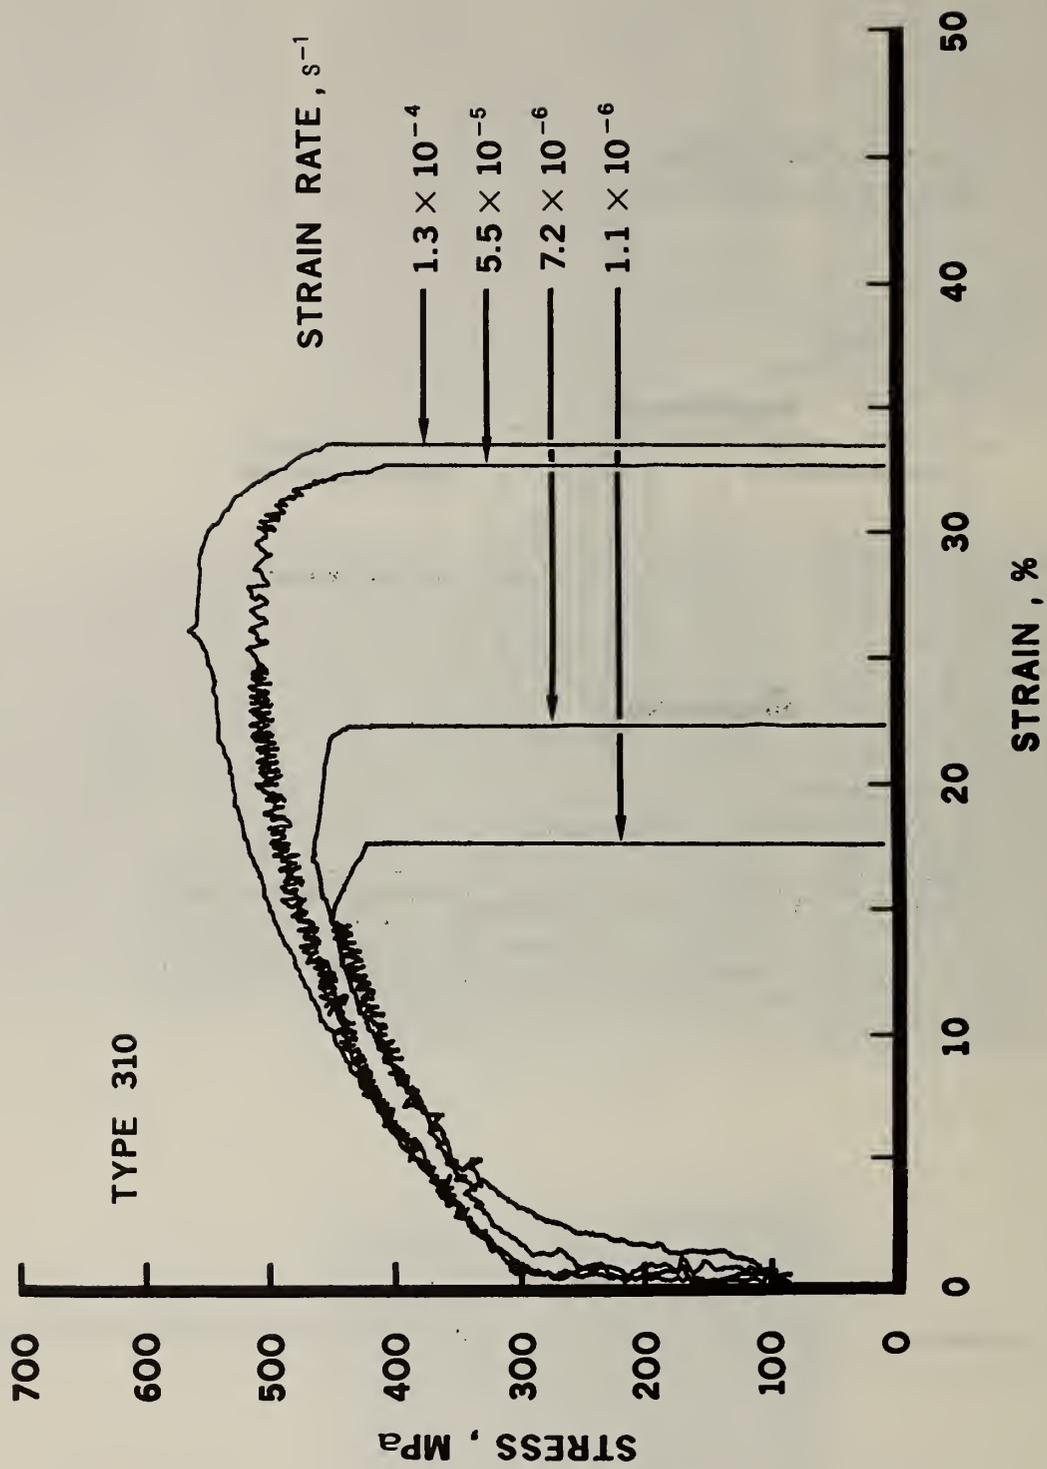
Fig. 4. Effect of strain rate on stress-strain curves of Type 310 specimens tested in H_2O/H_2S at $540\text{ }^\circ\text{C}$.

Type 310: Specimens were initially tested at 540°C(1000°F) in the H₂S environments. Typical stress-strain curves are shown in Fig. 4, and the various fracture parameters are presented in Fig. 5 and Table 3. It can be seen that the UTS, elongation and % reduction in area (RA) are markedly reduced at strain rates of 7.2×10^{-6} /s and slower. SEM examination indicated that the reduction in the tensile parameters was associated with the appearance of large numbers of surface cracks, Fig. 6. These formed throughout the gauge section and were approximately perpendicular to the stress axis, e.g., Fig. 6(d). In the case

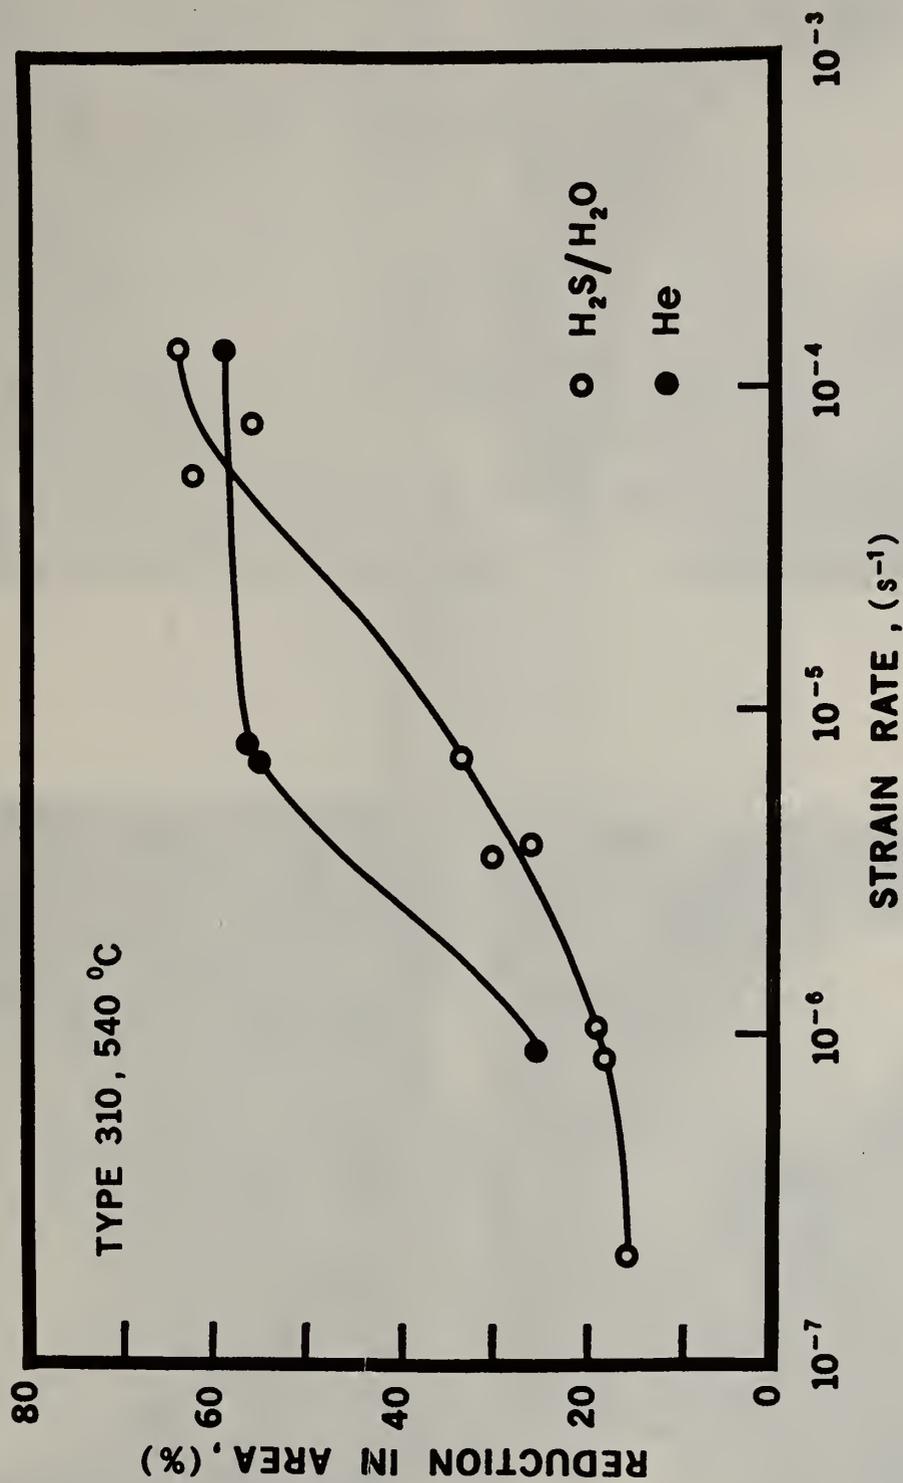
Fig. 5. Ductility as reduction in area versus strain rate for Type 310 specimens tested in gaseous H₂O/H₂S and He at 540 °C (1000 °F).

For comparison purposes, specimens were also tested in He at 540°C(1000°F). The results, Fig. 5, indicated that the RA was again decreased at the lower strain rates, and SEM examination revealed the presence of intergranular cracks. A visible oxide film was observed, raising the possibility that this was responsible for the reduced RA. The supplier's analysis of the He gave a value of O₂ content of 0.1 to 0.5% while H₂O was listed at 2-250 ppm. Accordingly, further testing was carried out at a strain rate of 10⁻⁶/s in He which was first passed through heated Ti filings, phosphorus pentoxide, and a liquid-nitrogen trap; tests were also carried out in Ar and vacuum (2 x 10⁻² Torr). Intergranular cracking occurred in each case, Fig. 7. However, a visible oxide film was detectable in each case, so that the environments cannot be regarded as inert. A hard vacuum test cell probably would have prevented the oxide on the specimens, but equipment and time were not available to test this idea.

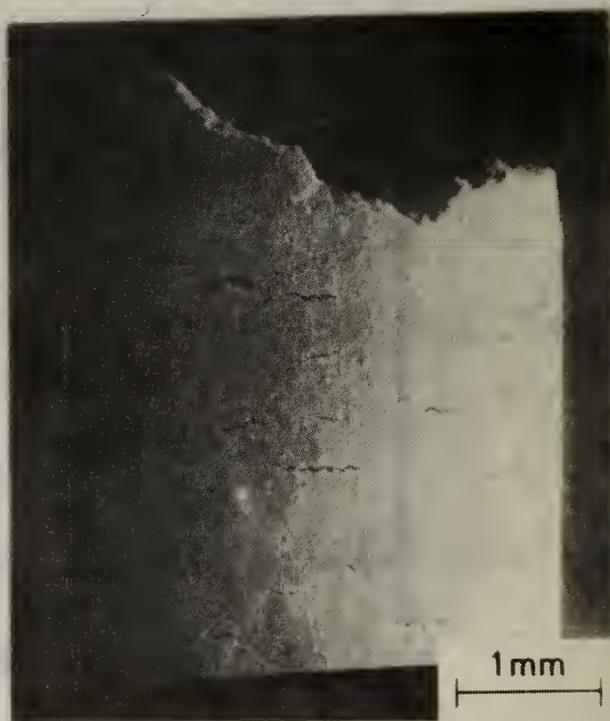
Fig. 6. Scanning electron micrographs indicating the effect of strain rate ($\dot{\epsilon}$) on the fracture of Type 310 specimens when tested in H_2O/H_2S at 540 °C (1000 °F).

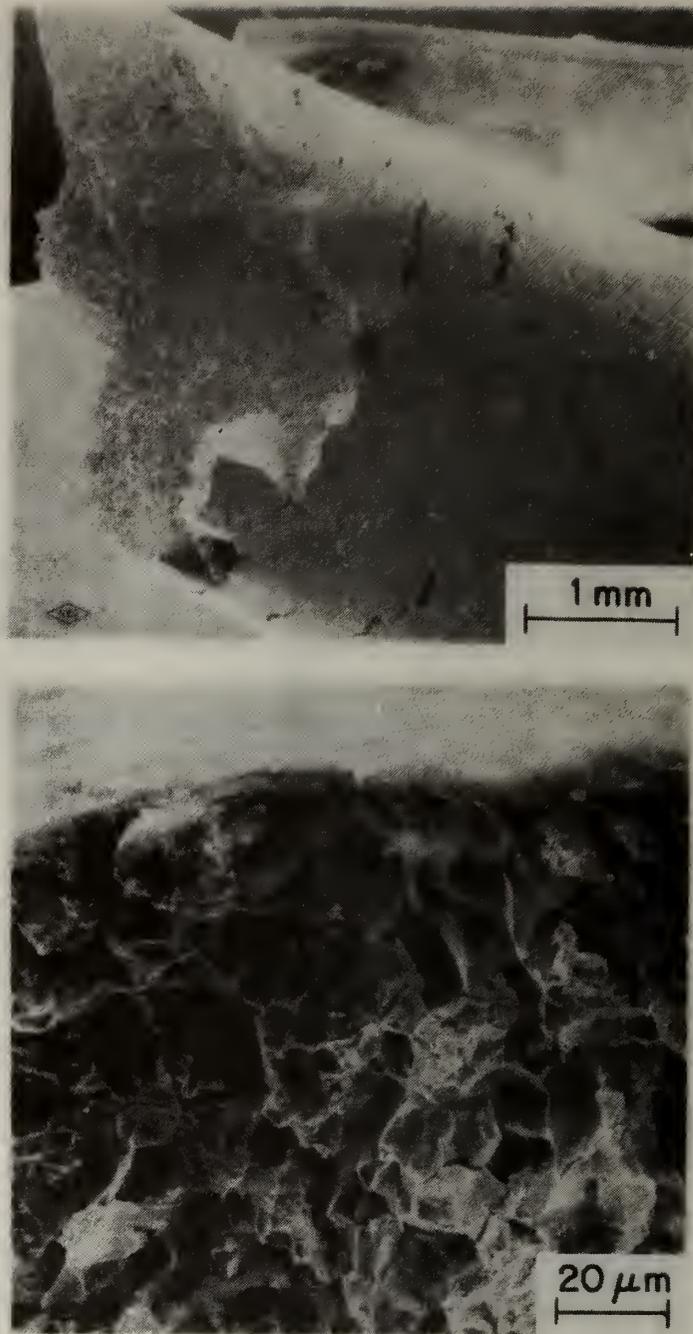
Fig. 8. Scanning electron micrographs of a Type 310 specimen tested in H_2 at 540 °C at a strain rate of $10^{-6}/s$, showing the primary fracture and numerous secondary intergranular cracks (above), and the zone of intergranular failure on the primary fracture surface (below).

Subsequent testing in a reducing environment of H₂ also produced a thin interference oxide film on the surface of the specimens. Cracking was also detected in these specimens in tests at 540°C(1000°F) at a strain rate of 10⁻⁶/s. Figure 8 shows the intergranular cracking on the surfaces of the gauge section, and the intergranular facets on the primary fracture surface. The rim of intergranular cracking extended 250-400 μm from the free surface, and the remaining fracture surface corresponded to ductile shear.

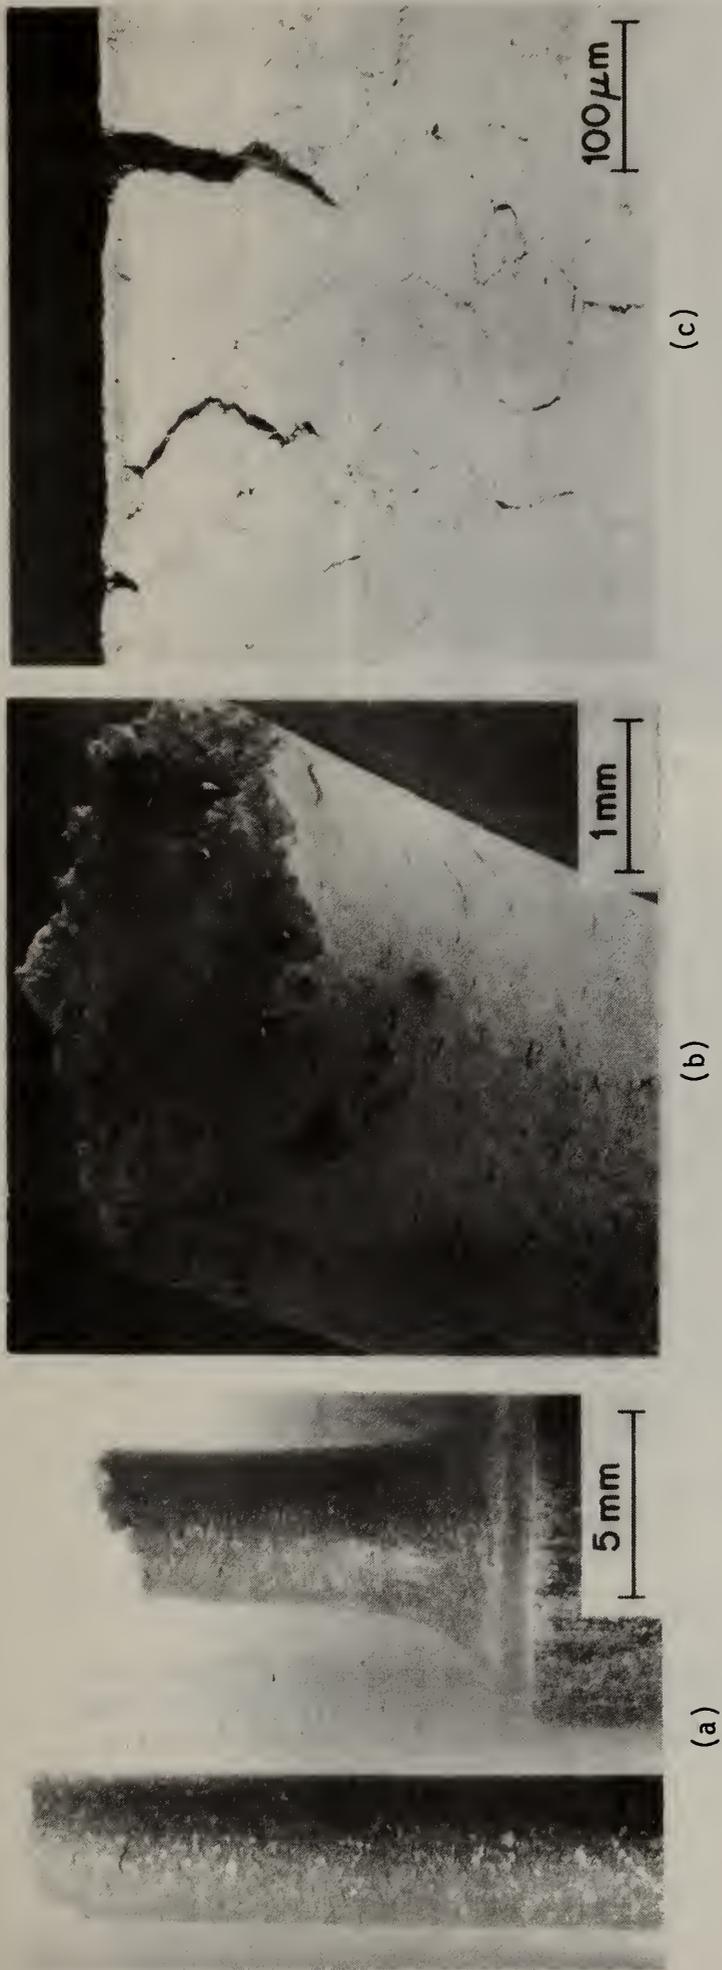
Fig. 9. Type 310 specimen tested in air at 815 °C (1500 °F) at a strain rate of 10^{-6} /s. (a) Photomicrograph of the fractured specimen. (b) Scanning electron micrograph at the region of fracture. (c) Photomicrograph of the sectioned specimen near the fracture.

intergranular cracking observed at 540°C(1000°F). The intergranular nature of the secondary cracks is evident from Fig. 9(c). Intergranular cracking also occurred in the test at 1040°C(1900°F), thus ruling out the possibility that sensitization is necessary for this form of failure. The RA was 21%, UTS 76 MPa(11 KSI) in this case, and the elongation 41%. The latter was probably due to the more uniform yielding over the entire reduced section at the higher temperature.

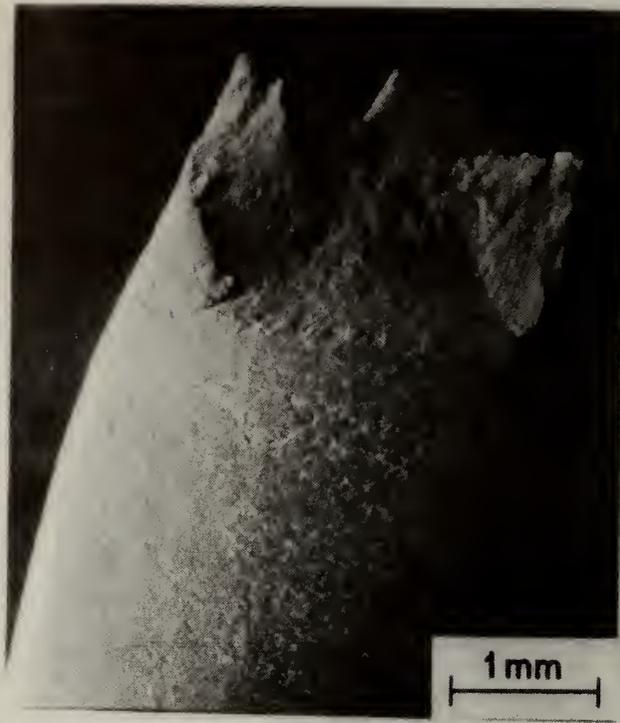
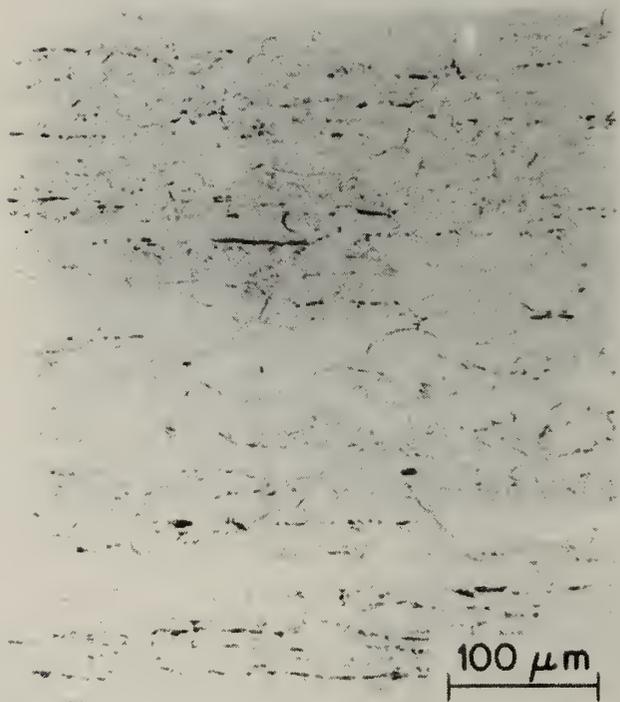
Fig. 10. Scanning electron micrograph and photomicrograph of Type 310 specimen showing the ductile fracture and partially sensitized grain boundaries after testing in He at 370 °C (700 °F) at a strain rate of 10^{-6} /s.

To further investigate the role of sensitization, specimens were tested at a strain rate of 10^{-6} /s in dry He and H₂ at 370°C(700°F) and 450°C(840°F), both below the nominal temperature range for sensitization. Examination of fractured specimens suggested that partial sensitization had in fact occurred, Figs. 10(b) and 11(b). However, the primary fracture was entirely ductile and no secondary intergranular cracks were detected, Figs. 10(a) and 11(a). The tensile properties were higher than in comparable tests at 540°C(1000°F), e.g., Fig. 12. In a further attempt to separate the effect of sensitization from that of combined thermo-mechanical processes, a test was made by heat-treating the unstressed specimen at 540°C(1000°F) for a time equivalent to the time required for specimen failure when tested at a strain rate of 10^{-6} /s (approximately 60h). The Type 310 specimen failed in a ductile manner when subsequently tested at 540°C(1000°F) at a higher strain rate of 10^{-4} /s. These tests showed the need for simultaneous application of the slow strain rate (10^{-6} /s) and the sensitization temperature (>450°C) for the occurrence of intergranular cracking.

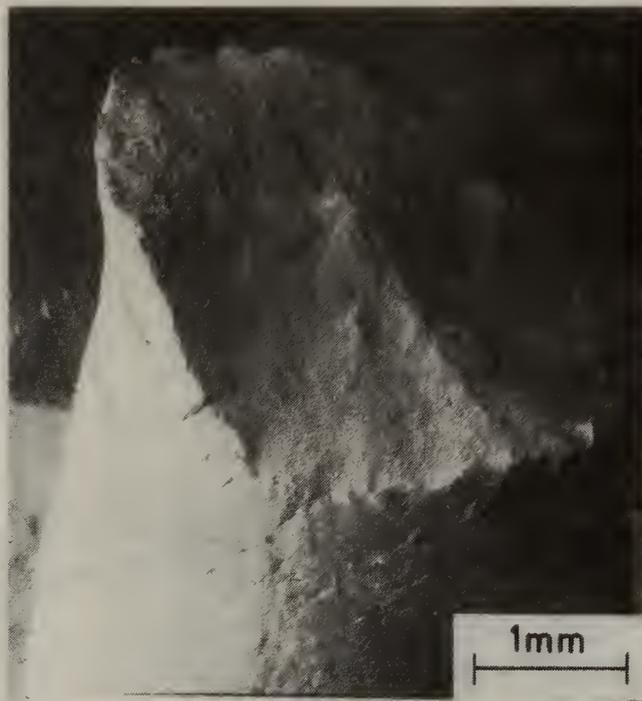
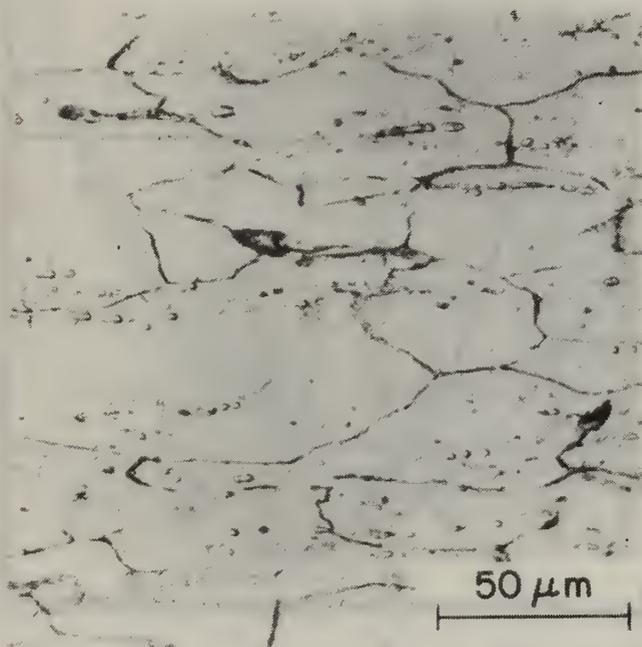
Fig. 11. Scanning electronmicrograph and photomicrograph of Type 310 specimen showing the ductile fracture and partially sensitized grain boundaries after testing in H_2 at $450\text{ }^\circ\text{C}$ ($840\text{ }^\circ\text{F}$) at a strain rate of $10^{-6}/\text{s}$.

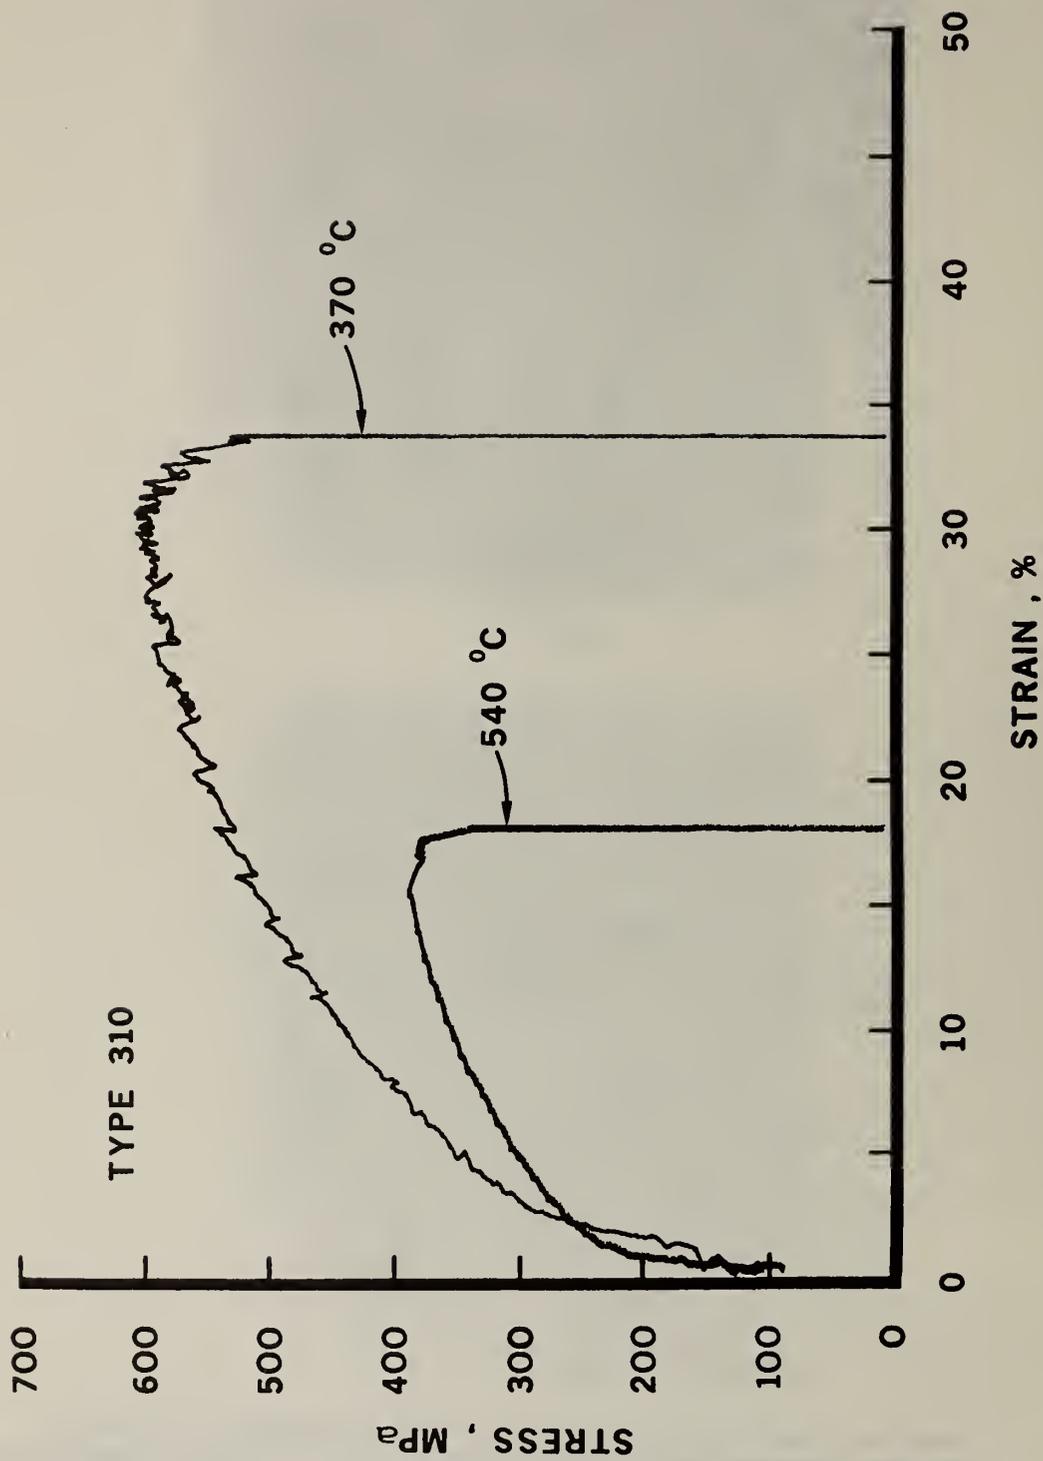
Fig. 12. Stress-strain curves for Type 310 specimens showing the effect of temperature when tested in dry He (passed through inert gas purifier) at a strain rate of $8.43 \times 10^{-7}/s$.

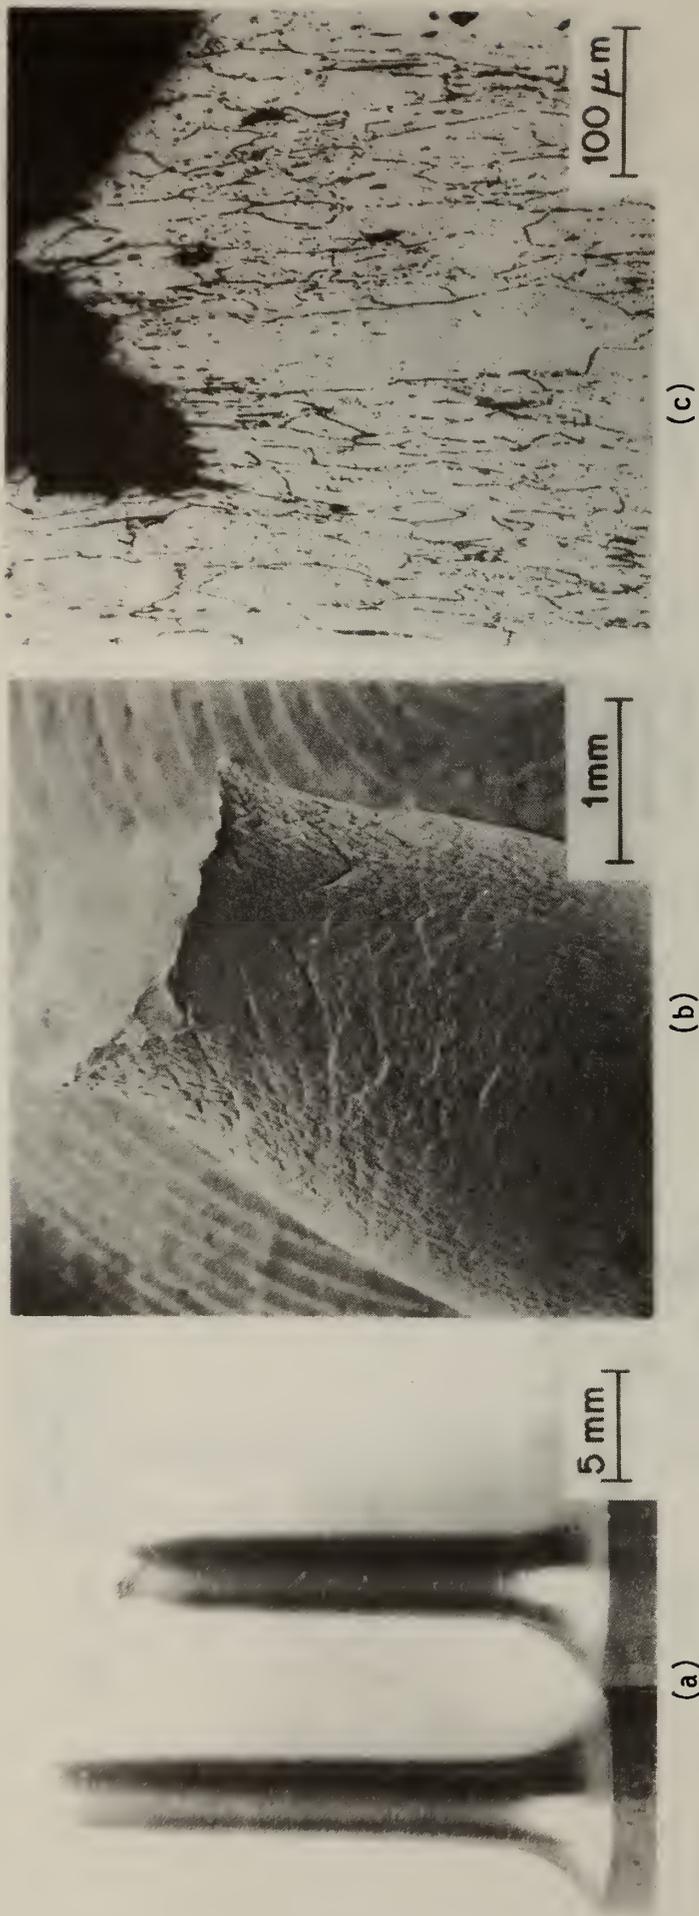
UTS — 602 MPa (87,300 psi)
 Elongation — 37.9%
 RA — 64.6%

Fig. 14. Type 310 specimen tested in He at 450 °C at a strain rate of 1×10^{-6} /s. (a) Photograph of the fractured specimen. (b) Scanning electron micrograph at the region of fracture. (c) Photomicrograph of the sectioned specimen near the fracture.

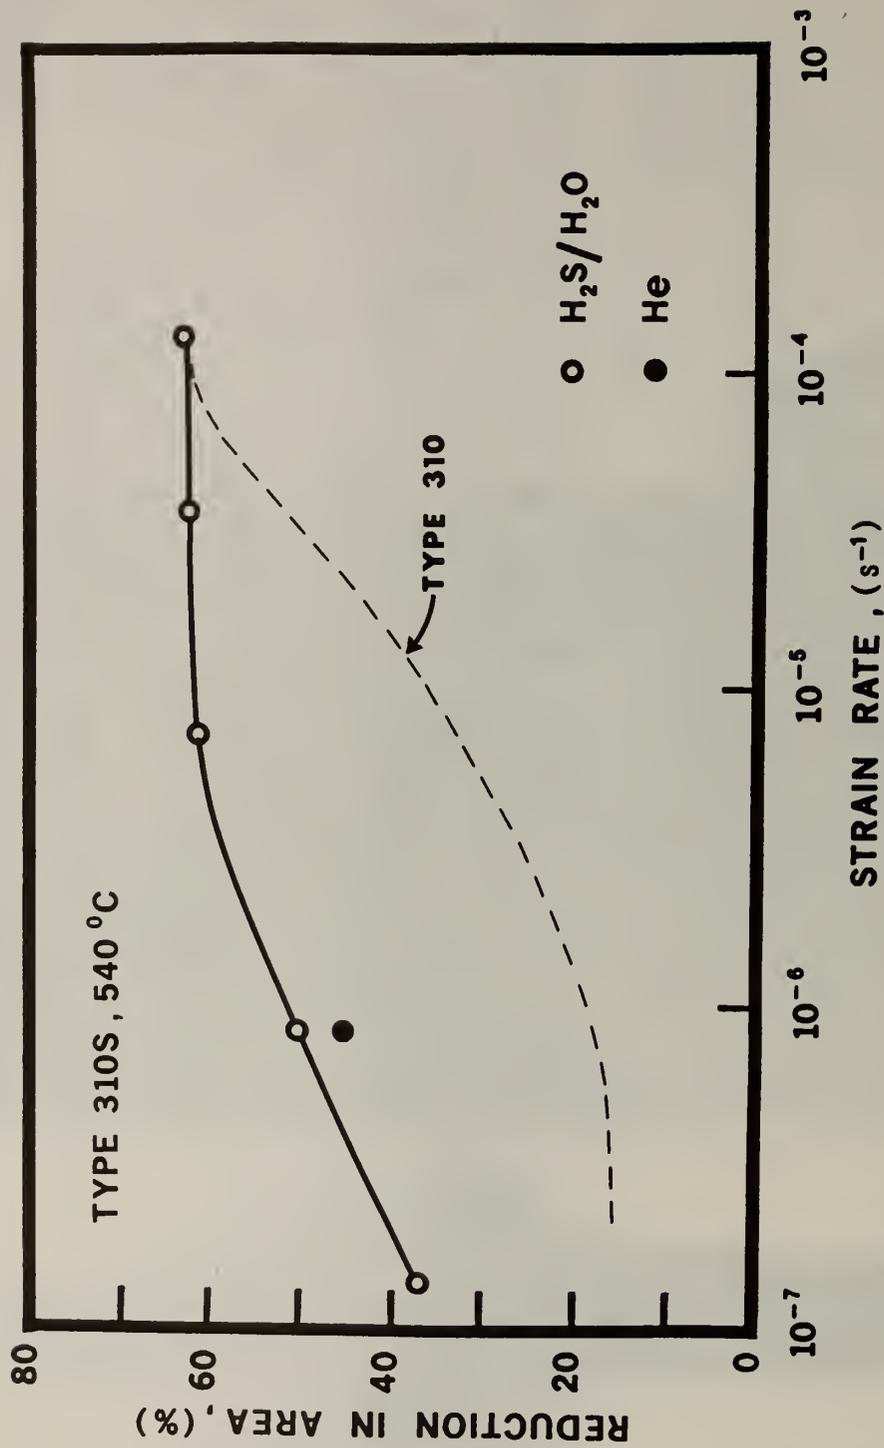
Fig. 20. Ductility as reduction in area versus strain rate for Type 310S specimens tested in gaseous H₂O/H₂S and He at 540 °C (1000 °F). Type 310 curve is shown for comparison.

Type 310S: The C content of this alloy was slightly lower than in Type 310, Table 1, and, if sensitization were important, this alloy should therefore be less susceptible to intergranular cracking. Initial tests were conducted in wet H₂S at 540°C(1000°F). In contrast to Type 310, no intergranular cracking was observed over the range of strain rates from 10⁻⁴ to 10⁻⁷/s. There was a reduction in the magnitude of elongation and RA at the strain rates of 10⁻⁶/s and 10⁻⁷/s, but these did not reach the low levels found in the Type 310, Table 4, Fig. 20.

Type 310S specimens tested in He and "house" vacuum (726mm Hg) at 540°C(1000°F) at a strain rate of 10⁻⁶/s exhibited elongation and RA values twice as great as were seen for Type 310 tested under the same conditions, see Fig. 20. However, numerous intergranular cracks were present in the Type 310S specimens. Clearly, the lower C content does not eliminate intergranular cracks. The reason for the absence of such cracks in the wet H₂S is not known, though it may be speculated that the scale formed in this environment protects the specimens from damaging environmental interaction. It should also be noted that creep resistance of materials has been reported to be greater in air than in He and vacuum [3,4]; this will be discussed further below.

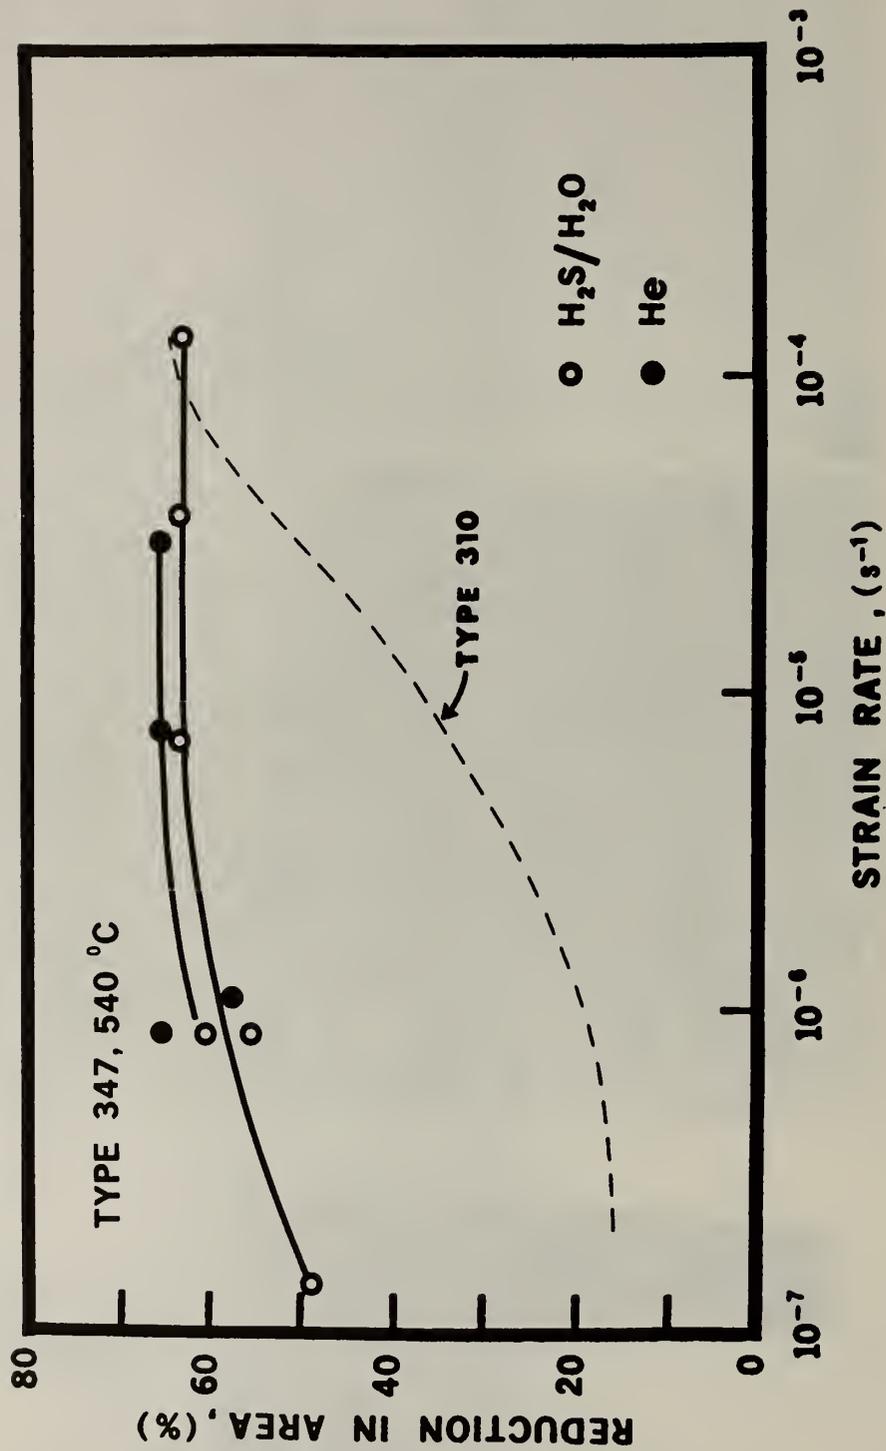
Fig. 28. Ductility as reduction in area versus strain rate for Type 347 specimens tested in gaseous H₂O/H₂S and He at 540 °C (1000 °F). Type 310 curve is shown for comparison.
